Major Scaffolding Project at the National Maritime Museum

# NATIONAL MARITIME MUSEUM - OCEAN COURT

# Alltask Collaborates with Willmott Dixon Interiors to replace windows

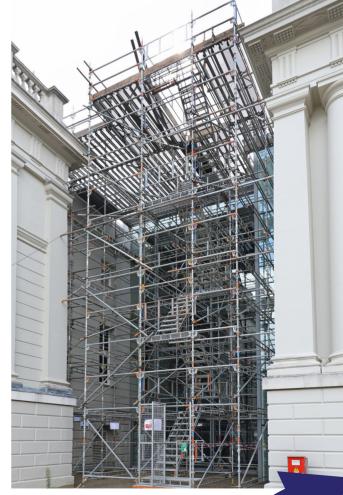
Once the plywood on the roof was felted by the roofing team, our scaffolders swiftly moved to the next phase. This involved installing HAKI mobiles and loading bays on top of the birdcage scaffold. These additions were crucial for the subsequent stages of the renovation, facilitating the transportation of materials and tools.
