## Scaffolding for Upgrading Sherrington Viaduct

# SHERRINGTON VIADUCT

## A Critical Infrastructure Project

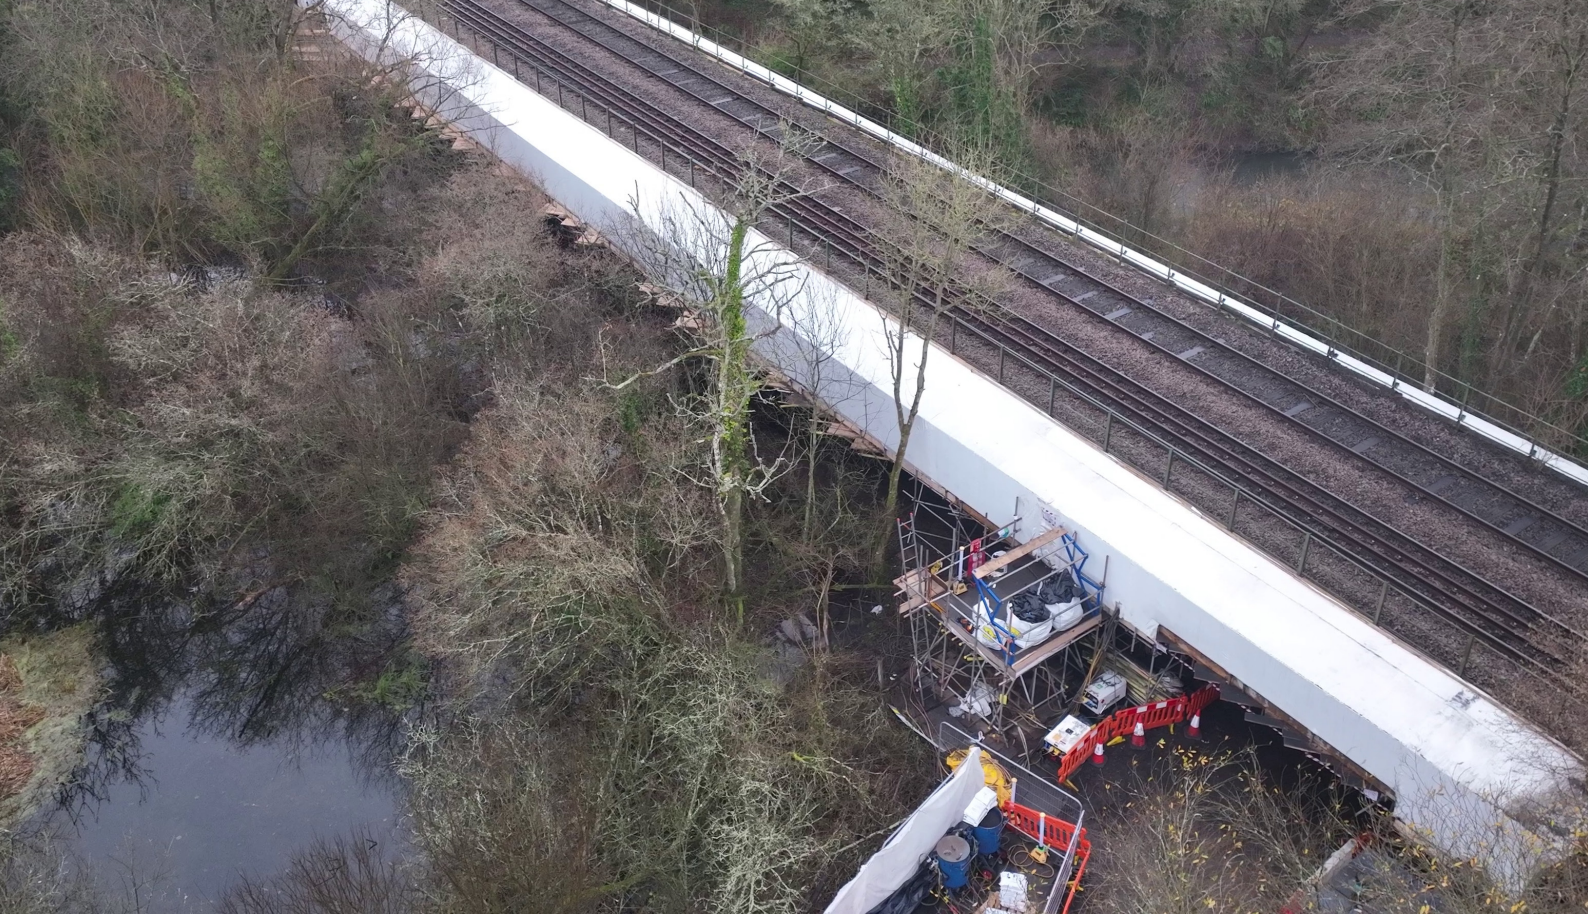
Alltask provided a purpose-built beamed access scaffold. The scaffold, supported by custom-engineered Mabey gallows brackets, was designed to ensure safe and efficient access for our client VolkerFitzpatrick and other contractors involved in the project.

We adopted the use of Mabey gallows brackets because the bridge was under stress and could not withstand additional loads if we were to suspend the scaffolding from the three main bridge girders.

We also needed to span over the River Wylde in span 4 before the salmon spawning season started. Additionally spans 2 and 3 are floodplains and the ground could not take any loads from grounded scaffolding without the

installation of major concrete foundations, which was not a viable option.

- **Beamed Access:** The scaffold utilised a beamed structure to span challenging areas, ensuring uninterrupted access.
- **Mabey Gallows Brackets:** Purpose-built brackets provided a reliable foundation, demonstrating innovative engineering solutions.
- **Safety-First Approach:** Alltask prioritised safety by adhering to industry standards throughout the project.
